**MISSOURI DEPARTMENT OF NATURAL RESOURCES
HAZARDOUS WASTE PROGRAM
SUPERFUND SECTION
ANNUAL REGISTRY SITE INSPECTION**

1. SITE NAME AND LOCATION		
SITE NAME West Lake Landfill	ADDRESS OR LEGAL 13570 St. Charles Rock Road Bridgeton, MO 63044	COUNTY St. Louis
2. DIRECTIONS TO SITE (Starting from nearest public road, be specific, i.e. highway, street or county road, direction of travel, miles to nearest tenth to the site) Traveling east on I-70 (just after crossing the Missouri River Bridge in St. Charles) take I-270 North (exit 232A-232B). After the interchange immediately turn right onto MO 180 West. At stoplight turn left onto St. Charles Rock Road and go 0.9 miles to landfill entrance on SW side of road.

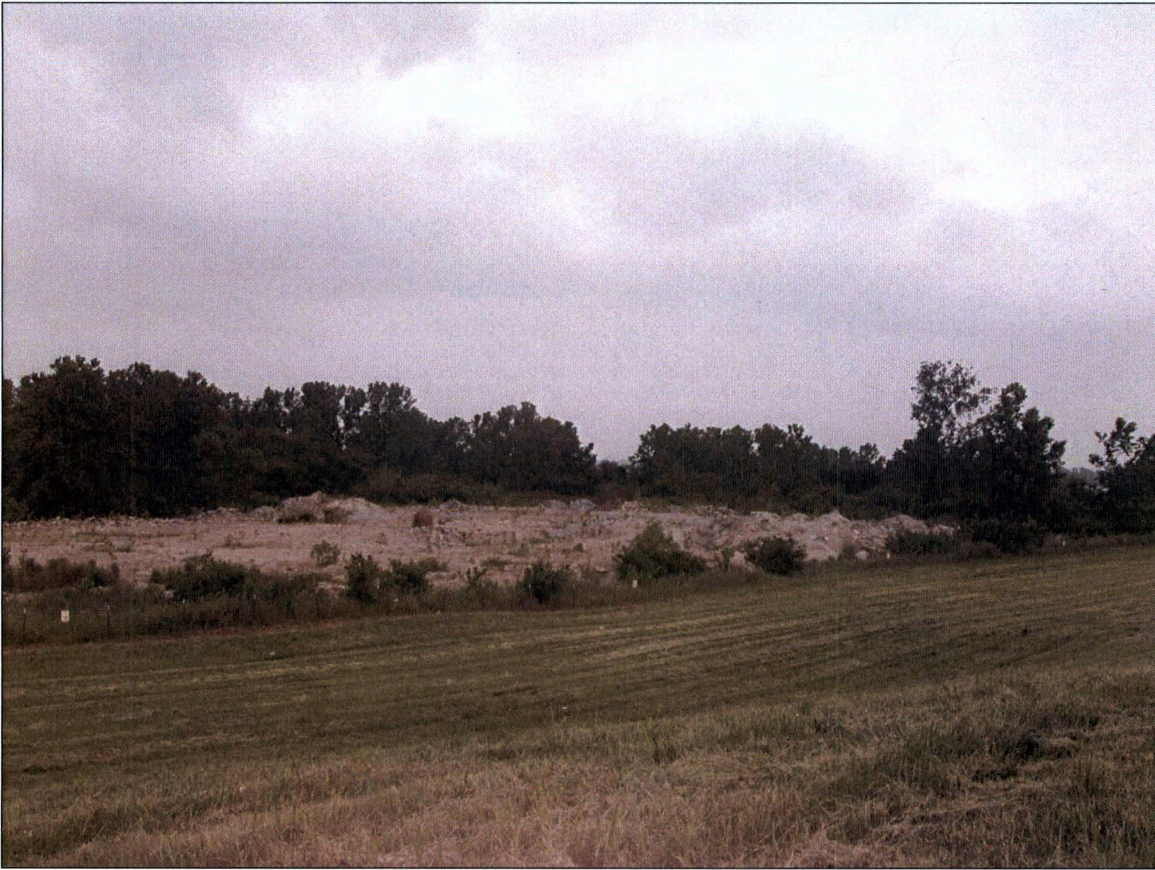
Photo 1 – Looking North

PHOTO ID NUMBER	DATE	DESCRIPTION
1	06/09/2011	View of OU-1, Area 2 from the Closed Demolition Landfill showing perimeter fencing and landfill cover.
2	06/09/2011	View of OU-1, Area 2 from the Closed Demolition Landfill showing perimeter fencing and landfill cover.
3	06/09/2011	View of OU-1, Area 2 from the Closed Demolition Landfill showing perimeter fencing and landfill cover.
4	06/09/2011	View of Site Entrance Road off St. Charles Rock Road from the Closed Demolition Landfill showing access controls (fencing).
5	06/09/2011	View of on-site soil borrow pile from the Closed Demolition Landfill.
6	06/09/2011	View of transfer station and asphalt batch plant from the Closed Demolition Landfill.
7	06/09/2011	View of site offices and weigh station from the Closed Demolition Landfill.
8	06/09/2011	View of perimeter fencing around Area 1 from Former Active Sanitary Landfill access road.
9	06/09/2011	View of OU-1, Area 1 from the northern portion of the Former Active Sanitary Landfill showing landfill cover.

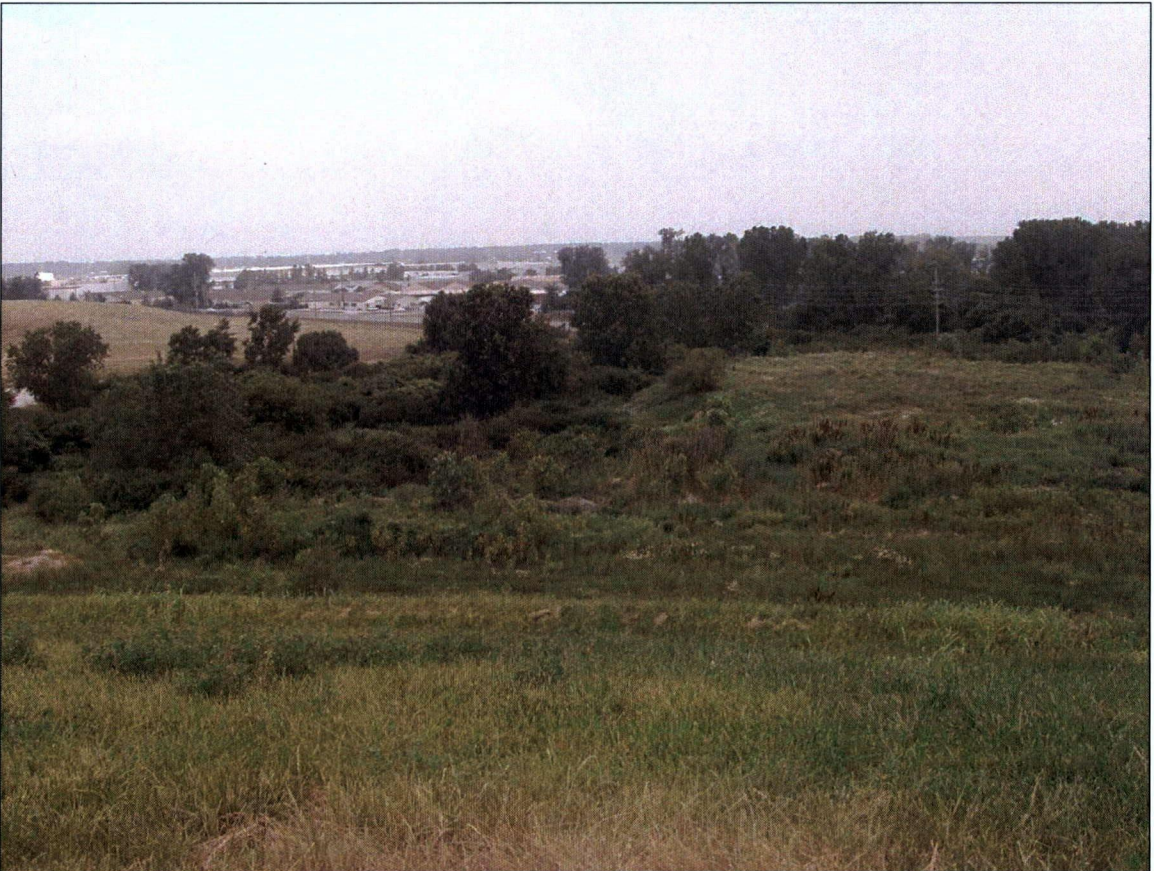
Photo 10 – Looking North

10	06/09/2011	View of OU-1, Area 1 from the northern portion of the Former Active Sanitary Landfill showing landfill cover.
11	06/09/2011	View of OU-1, Area 1 from the northern portion of the Former Active Sanitary Landfill showing landfill cover.
12	06/09/2011	View of OU-1, Area 1 from the northern portion of the Former Active Sanitary Landfill showing landfill cover.
13	06/09/2011	View of southern portion of the Former Active Sanitary Landfill and methane flare.
14	06/09/2011	View of southern portion of the Former Active Sanitary Landfill showing surface gas control tarps (odor mitigation) and stormwater control.
15	06/09/2011	View of southeast edge of the Former Active Sanitary Landfill showing surface gas control tarps (odor mitigation) and perimeter gas extraction wells.
16	06/09/2011	View of leachate holding tank.
17	06/09/2011	View of top of Former Active Sanitary Landfill showing area of subsidence.

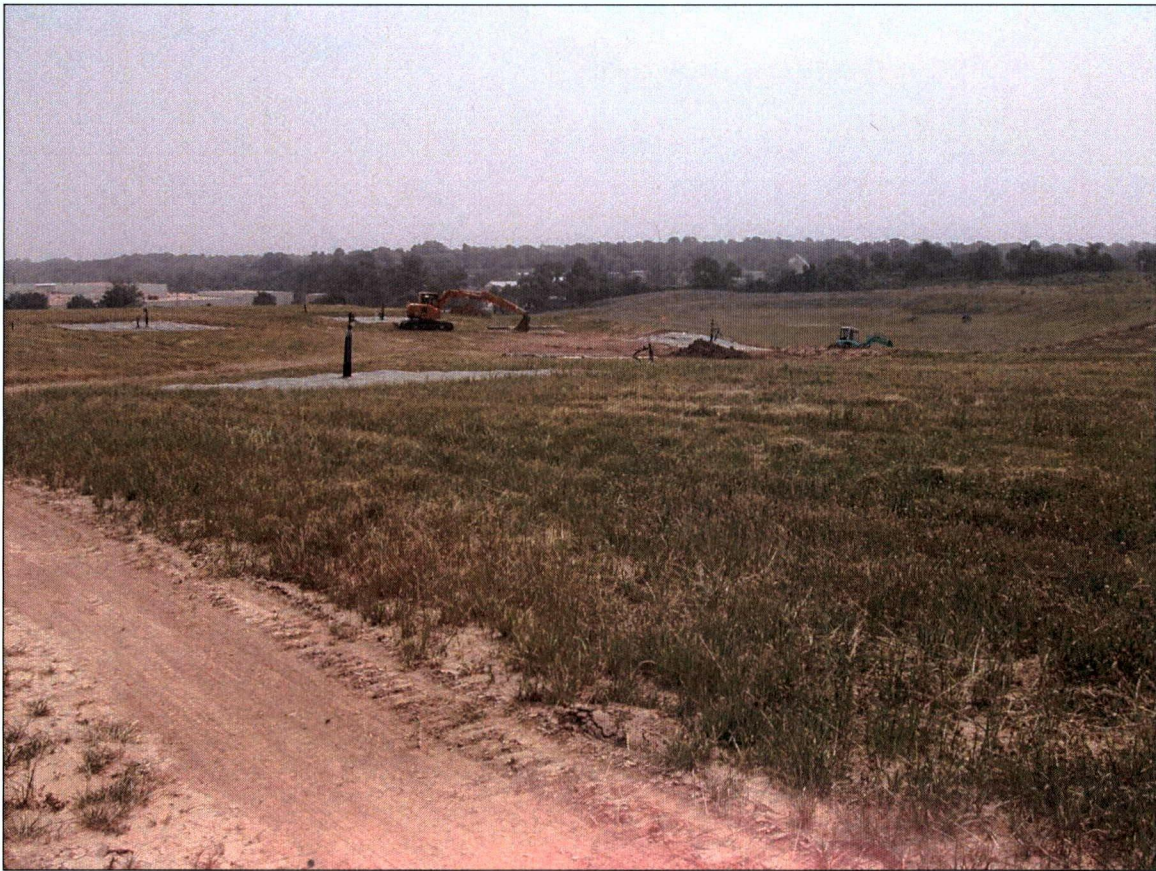
Photo 17 – Looking East

6. BRIEFLY DESCRIBE ANY ENVIRONMENTAL PROBLEMS NOTED DURING INSPECTION		
A Subsurface Oxidation (SSO) event has been detected in the Former Active Sanitary Landfill. This event is currently being monitored by sampling the gas extraction wells. Odor mitigation is being conducted by placement of 40 mil plastic liner over venting areas and negative pressure applied beneath the liner through the gas extraction system. Some subsidence has occurred at the top of the Former Active Sanitary Landfill which has affected the surface runoff. This is being corrected by installation of a new stormwater let down on the south side of the landfill. Overall, the SSO intensity and affected area have remained relatively stable.

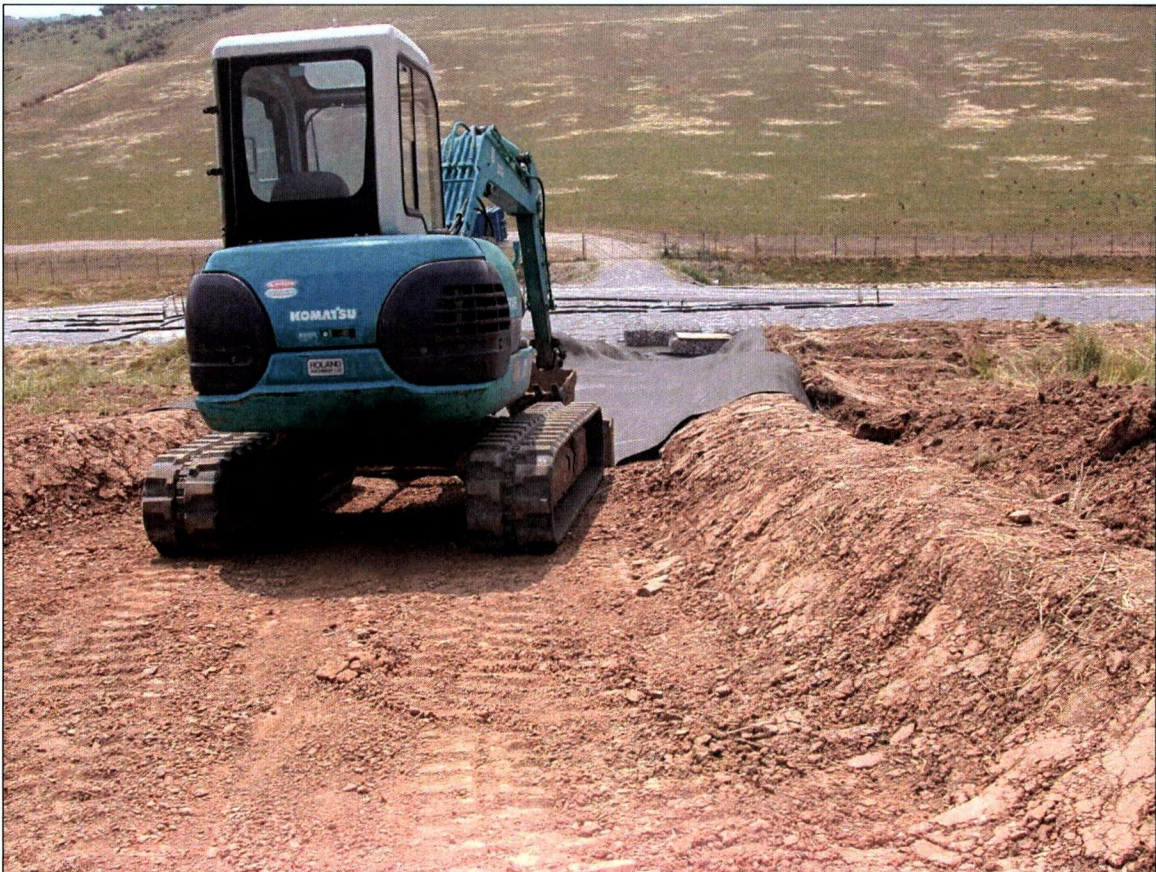
Photo 18 – Looking Southeast

18	06/09/2011	View looking down southeast slope of Former Active Sanitary Landfill showing construction of new stormwater let down.
